Environmental and Social Due Diligence, Impact  
Assessment and Road Safety Audit for the Moldova  
TEN-T Road Network Rehabilitation Project,  
DTM 55768

Project No. P12002-106

**Road Safety Audit**  
**Tranche 1: R7 Road**  
**Lot 1, Lot 2, Lot 3**

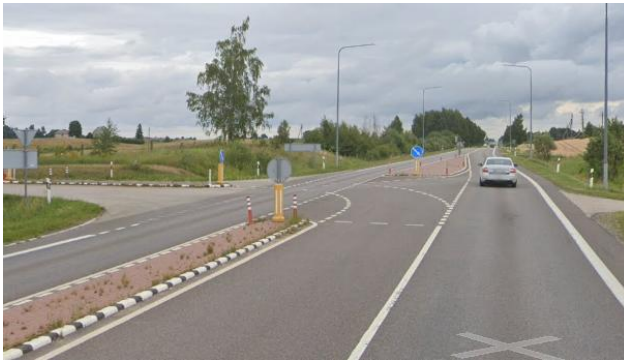
**Figure 5-2. Traffic island example and scheme**

The purpose of elevated safety islands (Pictures below) is to:

- Separate opposing traffic flows;
- Ensure that pedestrians safely cross a road in junction areas;
- Reduce the permitted speed from 90 to 70 km/h (in junction areas mostly);
- Maintain 70 km/h speed;

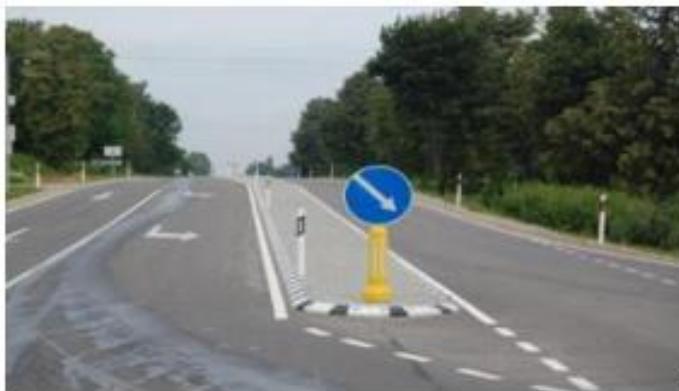
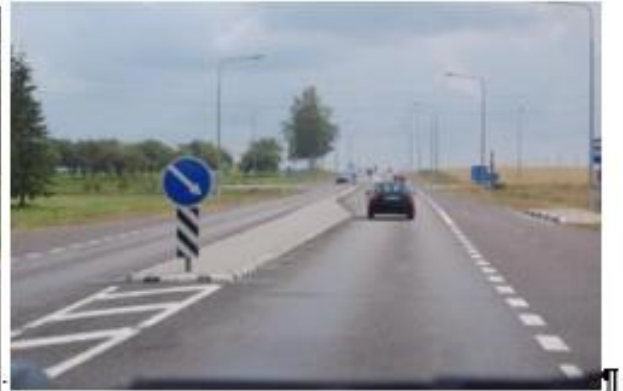
**Figure 5-3. Traffic islands for the left turn separation**

- Left-turn separation islands;

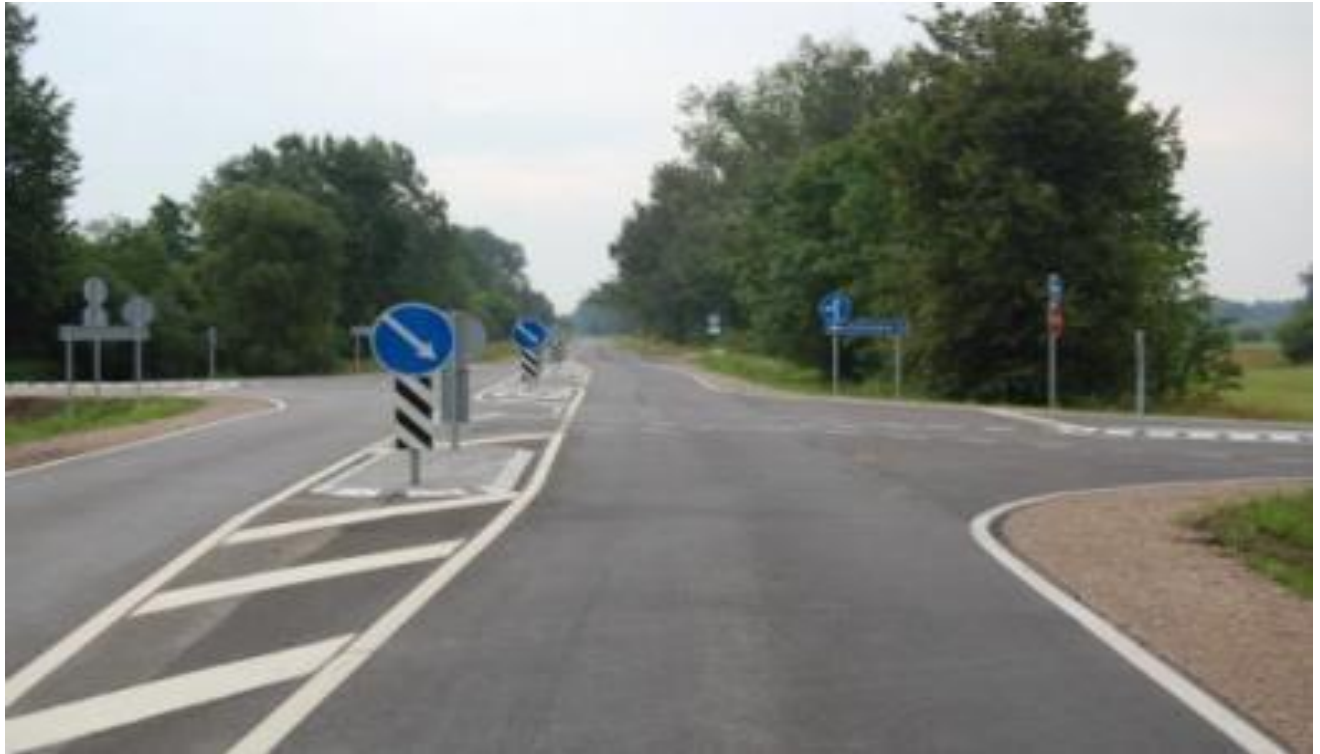
**Figure 5-4. Simplified Traffic islands**

- Simplified safety islands;

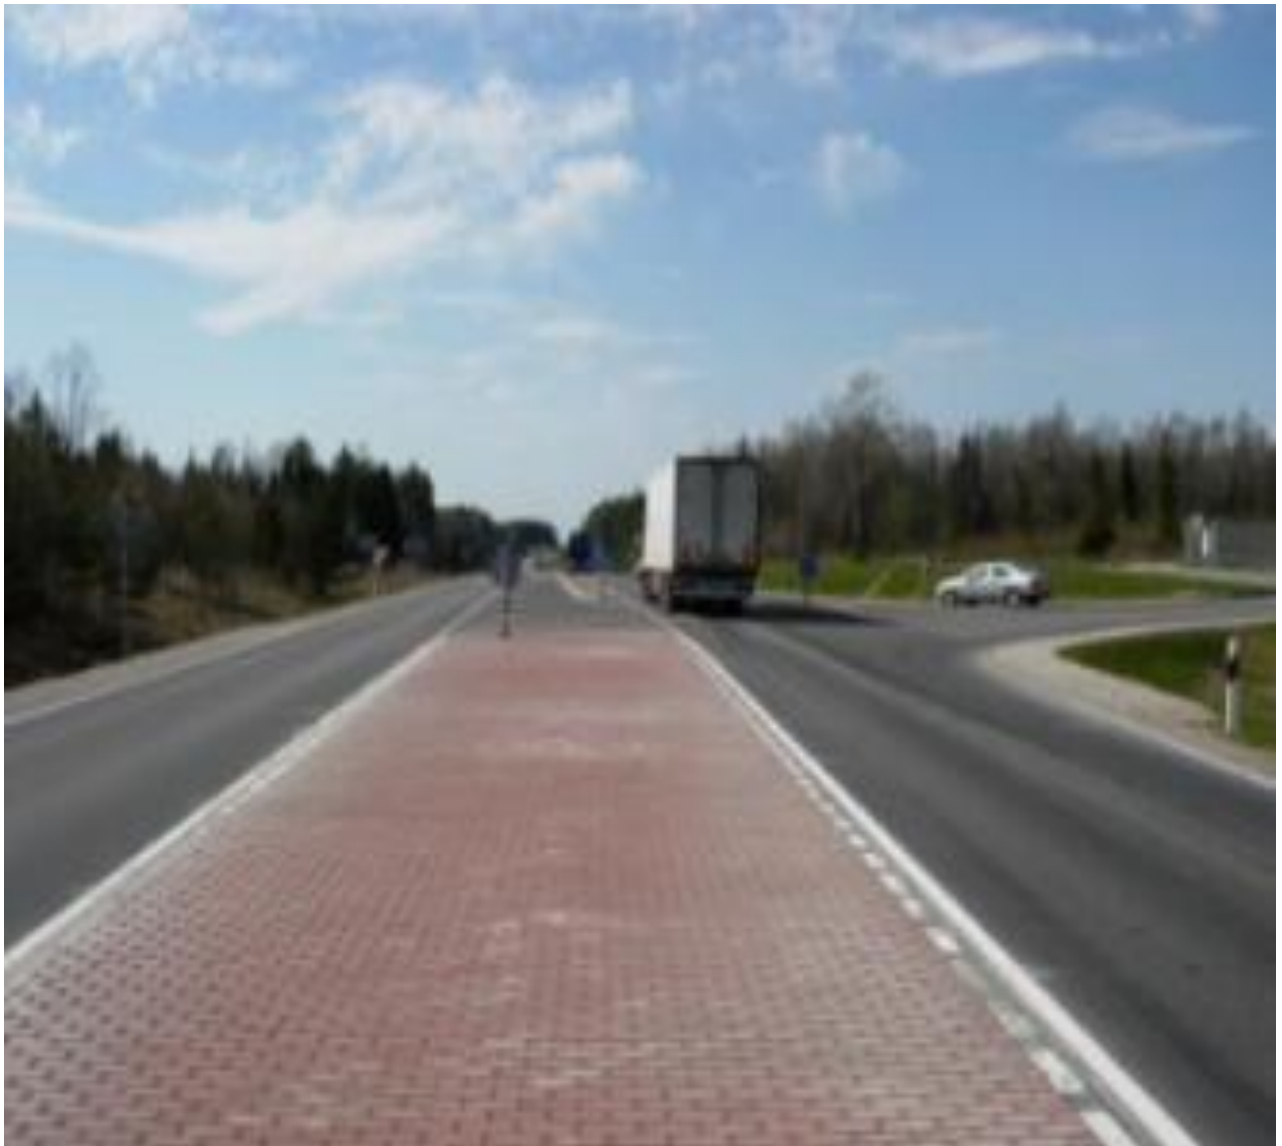
**Figure 5-5. Materials for elevated safety islands**

Various types of granite, concrete road kerbs and paving stones are usually used for the arrangement of elevated safety islands. Safety islands can also be assembled from elements made of rubber, plastic, concrete and other materials and installed on the pavement.

- It is recommended that white-coloured light-reflecting elements are installed at an island in order to improve the visibility of elevated safety islands at night, in winter or under bad meteorological conditions.
- It is recommended that distinct flexible light-reflecting studs are installed every 1—2 m. The distance between distinct flexible light-reflecting studs from the end of a safety island can be smaller in order to accentuate forms of a safety island. Distinct flexible light-reflecting studs are especially recommended at junctions without lighting.
- It is recommended that distinct flexible light-reflecting studs are installed directly on the pavement of a marked safety island.

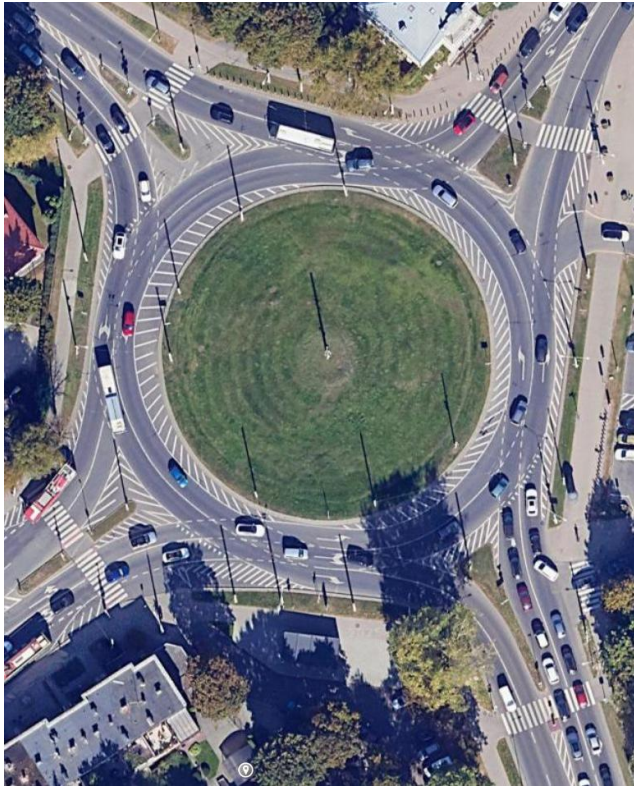
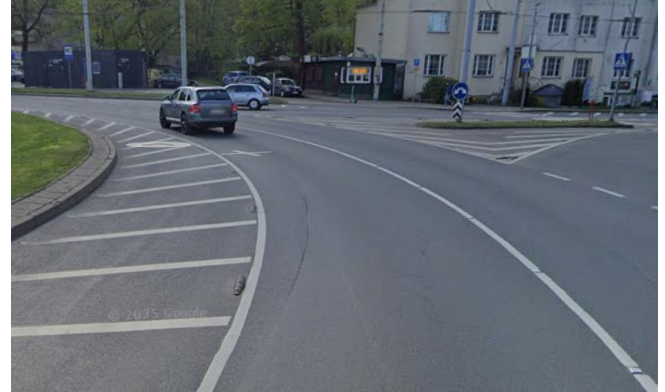
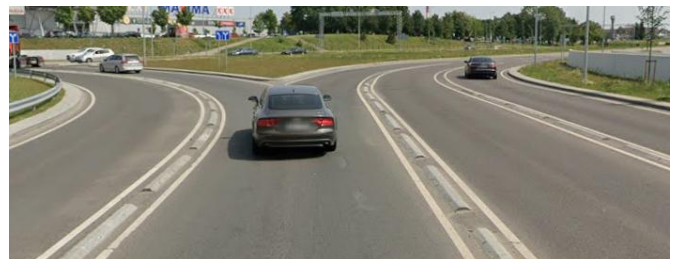
**Figure 5-11. Example of roundabout transformed from typical 2 lane roundabout to turbo-roundabout and typical turbo-roundabout**

*Example of typical roundabout reconfiguration to turbo-roundabout while using only horizontal marking without physical lane separation*

*Example of typical turbo-roundabout with physical lane separation*

It is strongly recommended to revise the current approach to roundabout design and adopt safer, more modern configurations—especially turbo roundabouts, which provide clearer traffic guidance and significantly reduce the number of conflict points compared to conventional multi-lane roundabouts. Turbo roundabouts are designed with physically or visually enforced lane separation, guiding drivers into dedicated paths and preventing dangerous lane-changing maneuvers within the roundabout. This design not only improves safety performance but also reduces driver stress, particularly in locations with high traffic volumes or complex turning movements. By limiting conflict zones and ensuring predictable vehicle trajectories, turbo roundabouts offer a safer and more intuitive alternative to traditional two- or three-lane roundabouts commonly observed in Moldovan cities and rural areas.

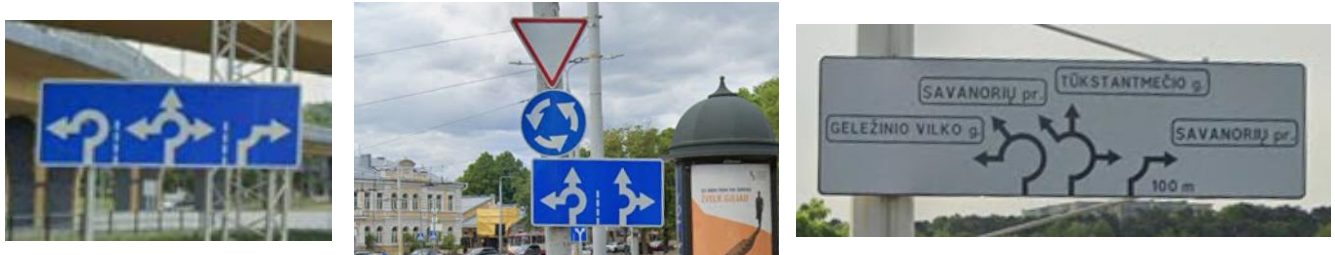
**Figure 5-12. Examples of road signs to inform about lane selection in roundabouts**

In addition, it is essential that drivers are properly informed about the required lane selection before entering the roundabout. This should be achieved through a combination of clear advance signage, pavement markings, and lane-assignment diagrams placed at an adequate distance from the roundabout, corresponding to the local design speed. Advance information enables drivers to choose the correct lane early, reducing last-minute lane changes and minimizing the likelihood of collisions inside the roundabout. Consistent and unified signing and marking

standards across the national road network would further enhance comprehension and predictability for all road users.

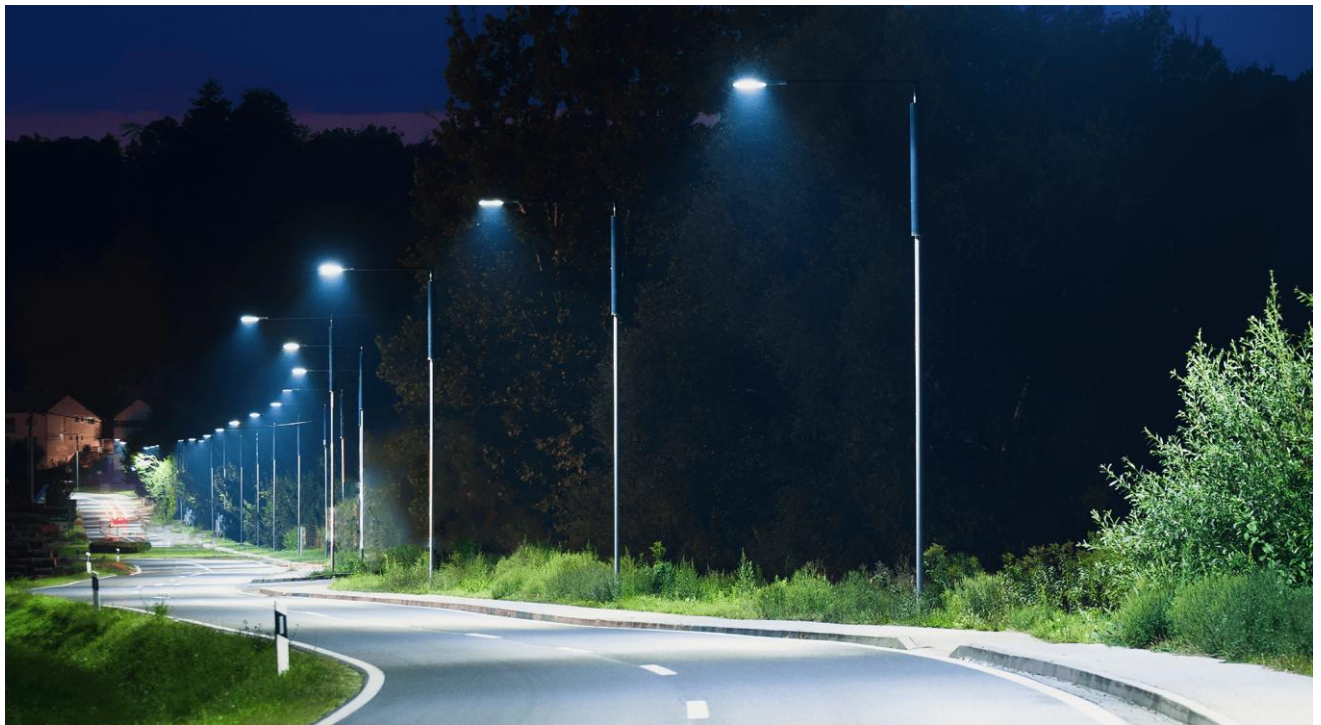
**Figure 5-14. Solar powered road lightning posts**

For these rural settlements, modern solar-powered lighting systems represent a particularly suitable and sustainable solution. Such systems utilize integrated photovoltaic panels to capture solar energy during daylight hours and store it for night-time operation, enabling reliable illumination without dependence on conventional electrical grid infrastructure. This approach offers substantial advantages for dispersed village environments by reducing installation complexity, minimizing operational costs, and ensuring long-term functionality even in areas with limited utility access. The implementation of energy-efficient LED solar lighting would provide an effective, resilient, and cost-efficient measure to improve night-time road safety across the targeted villages.

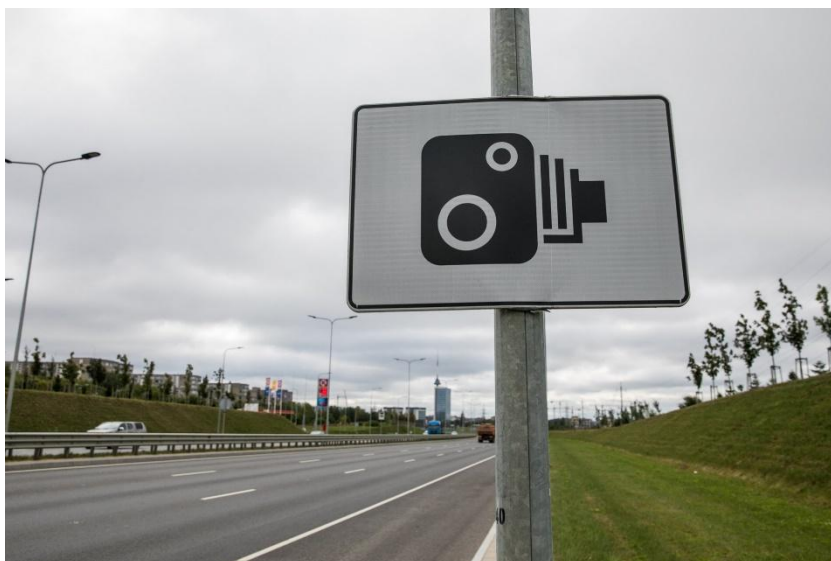
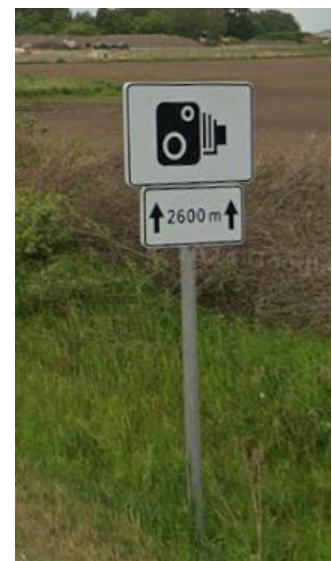
**Figure 5-17. a) Warning about point-speed enforcement b) Warning about average-speed enforcement**

Enforcement measures may include speed cameras and radar systems, which can generally be divided into point-speed enforcement and average-speed enforcement systems. In settlements where significant traffic pattern changes are expected — for example, where vehicles are likely to turn onto local roads or where multiple intersections are present — point-speed cameras may be more appropriate. However, in settlements where traffic primarily continues in transit along the main corridor, with limited side friction, few intersections, and minimal interruptions to traffic flow, average-speed enforcement is generally recommended. Such systems ensure that transit vehicles maintain a safe and compliant speed throughout the entire settlement section, rather than only reducing speed at isolated enforcement points.

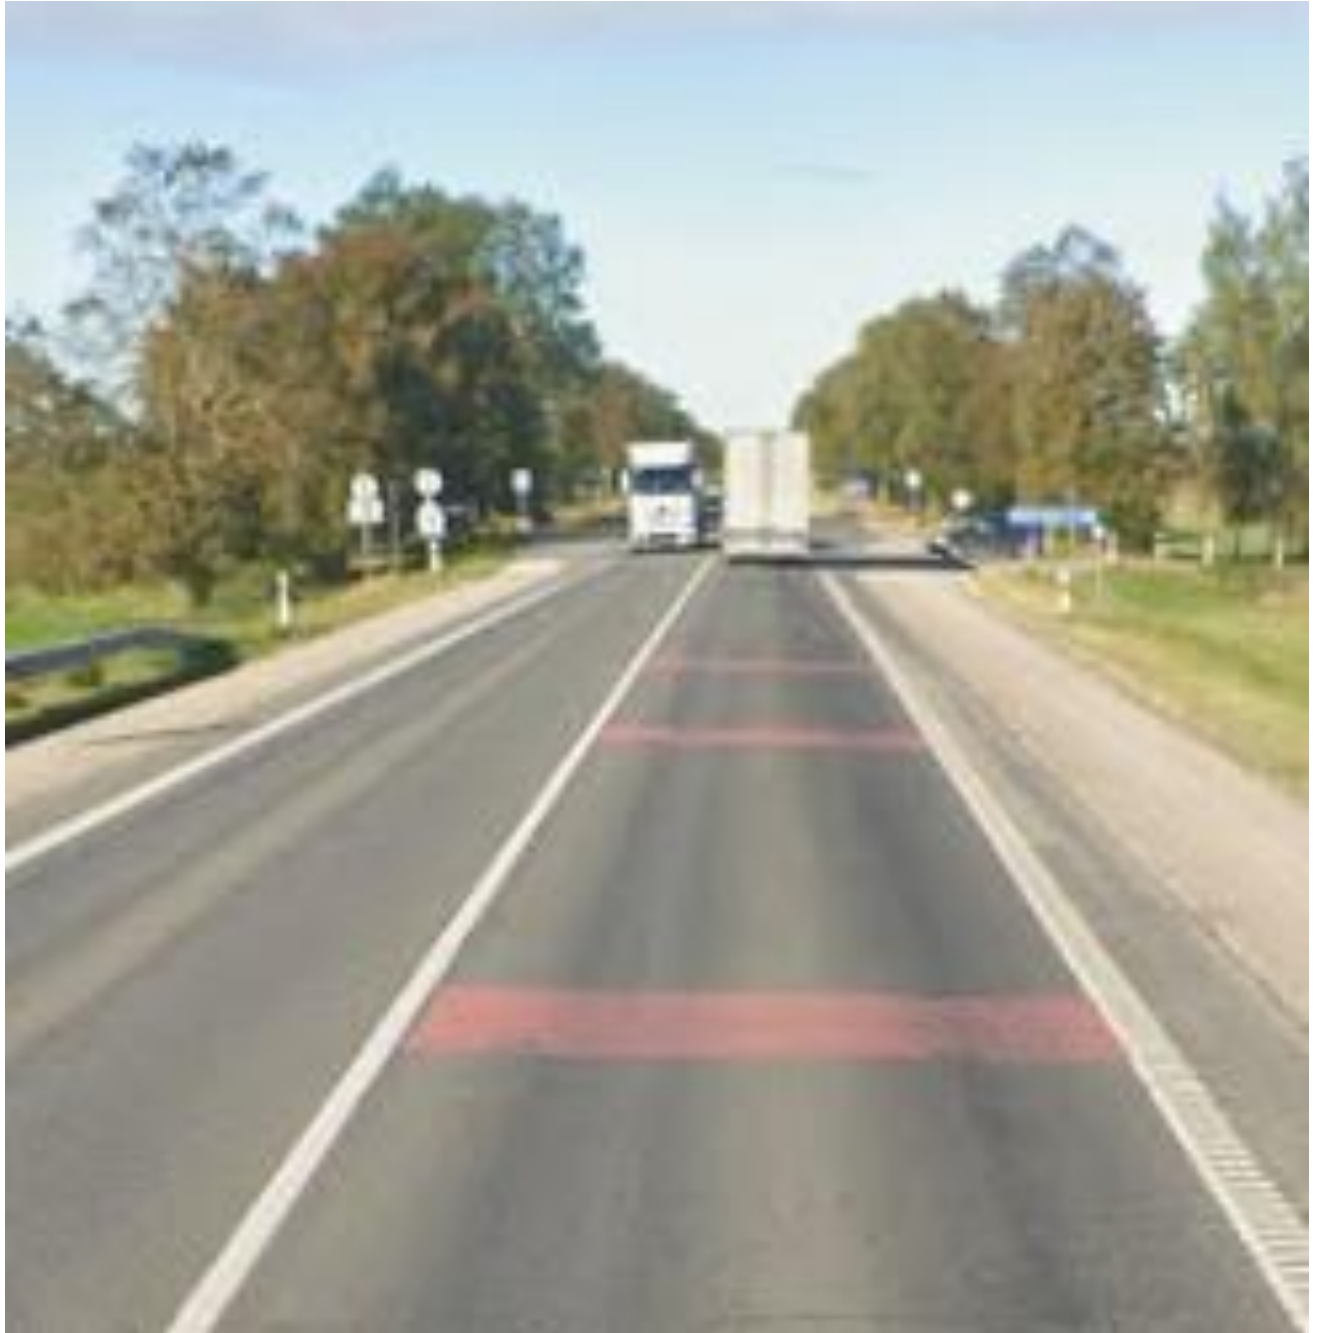
**Figure 5-18. Example of rumble strips**

Another measure already reflected in the proposed design solutions is the use of transverse rumble strips or milled noise markings at settlement entrances. Although these measures may not significantly reduce vehicle speed from a physical perspective, they create psychological discomfort and increase driver awareness, clearly indicating the transition into an area with different traffic conditions, increased roadside activity, and lower speed expectations.

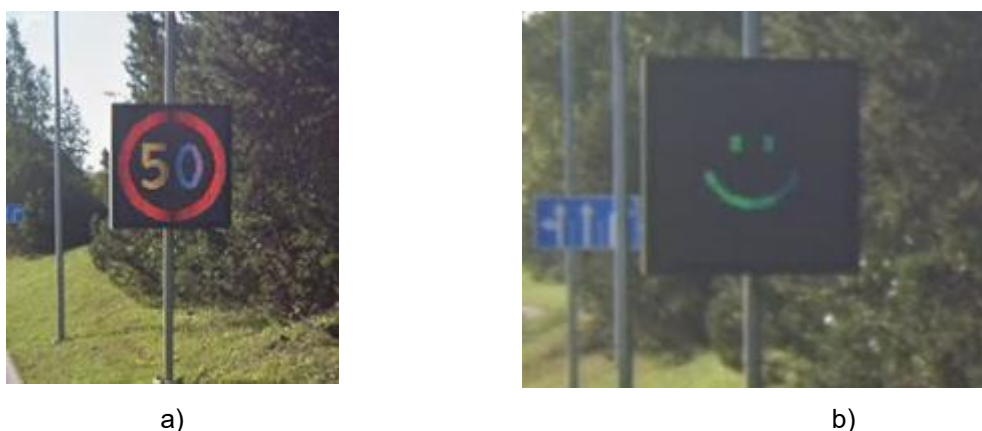
**Figure 5-19. a) Warning that the current driving speed is exceeding the speed limit b) Indication that the driving speed is below the speed limit**

Another measure that may be applied at the entries of settlement areas is the installation of dynamic speed display signs. These devices function as preventive speed management measures rather than enforcement tools, as they do not perform speed control or issue penalties. Instead, they provide a psychological effect on drivers by displaying the actual travelling speed of approaching vehicles and, in some cases, the applicable speed limit within the section.

Such systems are intended to increase driver awareness and encourage voluntary speed reduction, particularly at settlement entrances, near pedestrian crossings, schools, bus stops, or other sensitive roadside environments. Experience shows that immediate visual feedback regarding driving speed can positively influence driver behaviour and contribute to lower operating speeds without creating significant discomfort for road users or nearby residents.

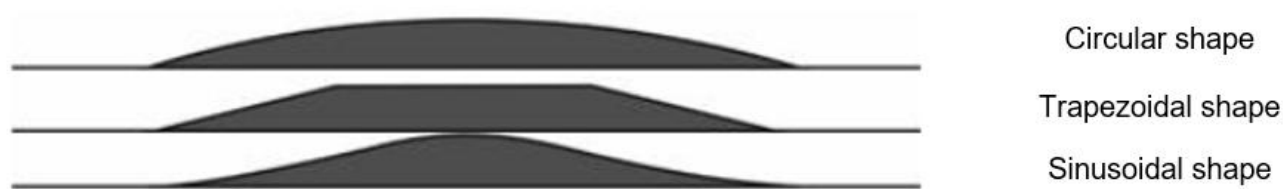
**Figure 5-20. Types of speed humps**

One of the most commonly used measures is the speed hump, which may be designed in different forms and therefore influence vehicle speeds differently. Circular-profile speed humps are generally the most effective in physically reducing speed, but they also have notable disadvantages, including increased vibration and noise levels, which may negatively affect nearby residential environments. For this reason, depending on the characteristics of the settlement, trapezoidal or sinusoidal speed humps are often more appropriate, particularly in areas with increased pedestrian activity or near intersections, where additional driver attention and lower approach speeds are required.

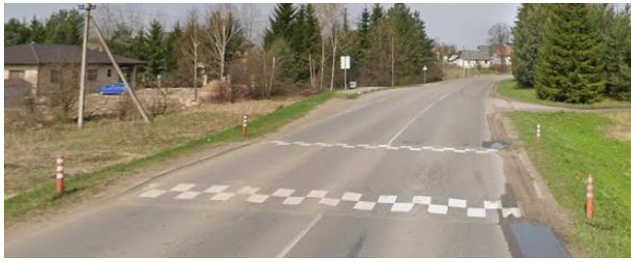
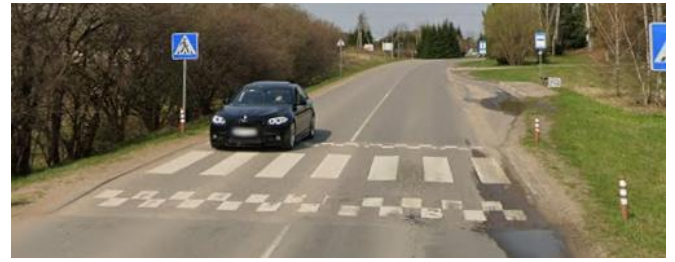
**Figure 5-21. a) Trapezoidal speed hump in the settlement b) Raised pedestrian crossing at the settlement**

Trapezoidal speed humps are typically not recommended on roads outside settlement areas or on streets that do not exhibit characteristics of an urban or residential environment, such as the absence of sidewalks, buildings, pedestrian activity, or where the road primarily passes through forested or undeveloped areas. In parallel, raised pedestrian crossings may also be applied as an effective traffic calming measure. These consist of pedestrian crossings installed on trapezoidal speed tables and are intended to improve pedestrian visibility, increase driver

awareness, and enhance overall pedestrian safety.

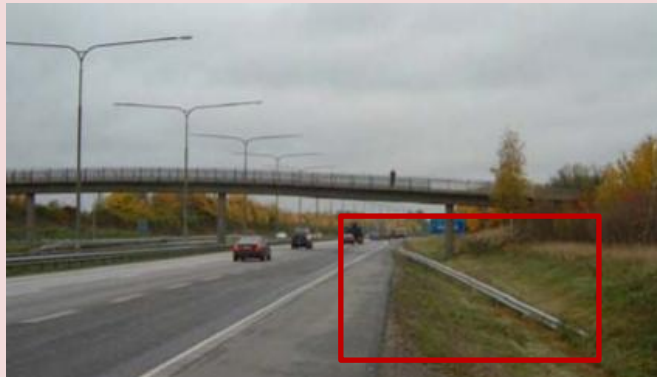
| 7. | PC 33+15 – 34+50<br>PC 38+10 – 40+00<br>PC 54+40 – 59+20<br>PC 70+80 – 72+00<br>PC 80+50 – 84+70 | <p>Straight ends of safety barriers are unsafe because a head-on collision with them is likely to result in serious consequences for the road user's health. Such design solutions should be replaced with safer, impact-</p> | M | <p>Lower the ends of the barrier, rotate them away from driving direction and carriageway, dig them into the ground. The design of turned off the road, lowered to the ground level and dig into the ground barriers ensures less severe consequences in terms of accidents. Also, this design of barriers can help the vehicle get</p> |

| | <p>PC 95+64 – 98+40</p> <p>PC 129+00 – 133+00</p> <p>PC 175+20 – 176+00</p> <p>PC 181+64 – 182+22</p> <p>PC 198+80 – 199+66</p> <p>PC 241+75 – 246+10</p> | <p>absorbing terminal ends or different layout of barriers.</p> | <p>back on the road instead of overturns or crashes to surroundings.</p> |

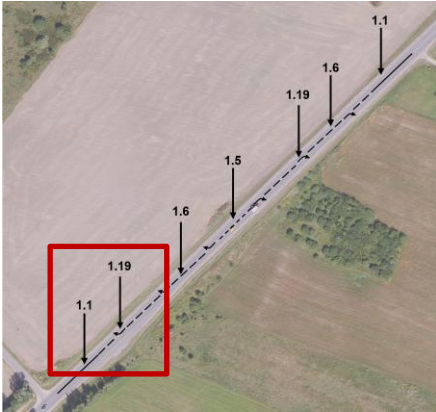
| 8. | <p>PC 43+50 – 44+50</p> <p>PC 48+50 – 49+50</p> <p>PC 50+20 – 51+20</p> <p>PC 51+40 – 52+40</p> <p>PC 79+50 – 89+50</p> <p>PC 83+20 – 84+00</p> <p>PC 89+20 – 90+10</p> <p>PC 91+50 – 92+50</p> <p>PC 96+20 – 97+10</p> | <p>Horizontal road markings 1.6 and 1.19 intersect, which may create visual clutter and confuse drivers about the relevance or meaning of the markings. Overlapping line types can reduce clarity and lead to uncertainty regarding lane guidance and overtaking regulations.</p> | <p>L</p> <p>It is recommended to position the 1.19 arrows between the 1.6 lines rather than directly on top of them. This approach will ensure that the markings remain clear, visually consistent, and easily interpretable for all road users, minimizing any potential misunderstanding about their purpose and validity.</p> |

| <div>PC 107+40 – 108+20</div> <div>PC 114+60 – 115+60</div> <div>PC 147+15 – 148+30</div> <div>PC 147+20 – 148+20</div> <div>PC 161+60 – 162+60</div> <div>PC 164+60 – 165+50</div> <div>PC 183+00 – 184+00</div> <div>PC 184+25 – 185+25</div> <div>PC 189+55 – 190+55</div> <div>PC 199+35 – 200+35</div> <div>PC 204+00 – 204+60</div> <div>PC 211+20 – 212+20</div> <div>PC 215+85 – 216+85</div> <div>PC 262+50 – 263+40</div> <div>PC 263+50 – 264+40</div> <div>PC 265+60 – 266+50</div> <div>PC 283+80 – 284+50</div> <div>PC 285+60 – 286+40</div> <div>PC 287+60 – 288+50</div> <div>PC 288+60 – 289+40</div> | <div></div> <div></div> <div>Example of horizontal marking</div> |

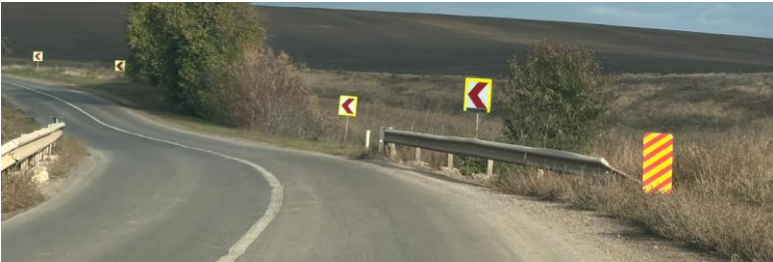
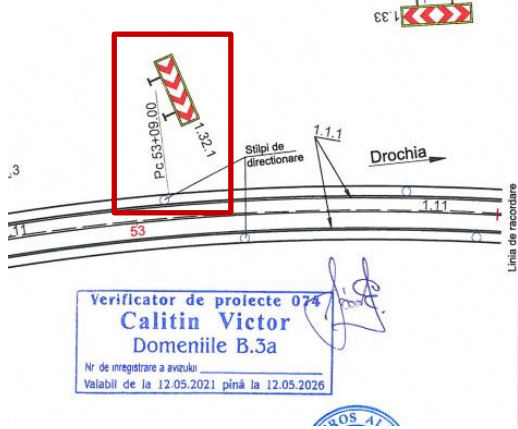
| 10. | PC 53+09<br>PC 242+59 – 244+50<br>PC 254+00 – 257+50 | <p>Using only a single road sign to warn about a curve may provide insufficient information for drivers. Continuous driver awareness is essential, especially along longer or gradually bending sections.</p> | L | <p>For curved sections, the use of segmented warning signs such as 1.34.1 or 1.34.2 is advised instead of single-symbol curve warning signs (e.g. , 1.32.1 or 1.32.2). This approach provides clearer visual guidance to drivers while reducing unnecessary sign density.</p> |

| | | | | Example of 1.34.2 signs in Moldova |

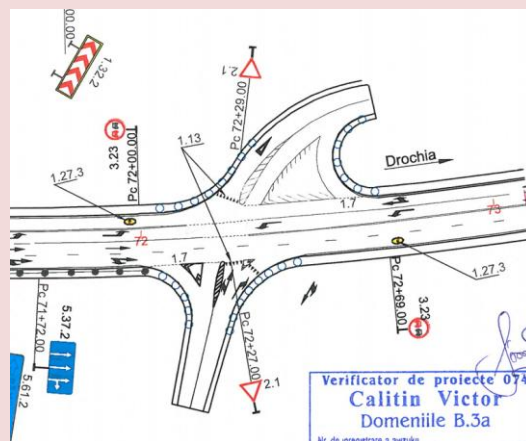
Option No. 1 (see enlarged in Annex C)

| 11. | PC 72+27 | <p>Several inconsistencies have been identified in the design of the proposed intersection:</p> <ol style="list-style-type: none"> <li>1. The intersection geometry is misaligned, which may affect driver visibility—particularly for those turning left from the minor roads. In the current design, drivers would need to turn their heads significantly to observe approaching vehicles on the main road, which can compromise safety and comfort.</li> <li>2. The horizontal road marking 1.13 is not applied consistently throughout the project; its layout varies across different locations, leading to non-uniform driver expectations.</li> <li>3. The advance direction sign (No. 5.37.2)</li> </ol> | L | <ol style="list-style-type: none"> <li>1. Where possible, the intersection geometry should be adjusted to form a regular four-leg layout, improving visibility and maneuvering conditions for all directions of travel.</li> <li>2. Ensure consistency in the application of horizontal marking 1.13, always positioning it at the junction between the main and side roads.</li> <li>3. Revise road sign No. 5.37.2 so that it correctly represents the number of lanes and their corresponding directions within the intersection, ensuring coherence between signage and pavement markings.</li> <li>4. It is recommended to designate a single traffic lane at the junction with the main road, without dividing it into separate lanes for different turning movements. Maintaining one shared lane for all directions will simplify the intersection layout, reduce marking clutter within the confined area, and improve the overall functionality and clarity of the junction.</li> </ol> |

does not accurately reflect the actual lane configuration and turning directions at the intersection. The information presented on the sign is inconsistent with the horizontal markings.

4. The proposed small traffic island on the minor road (approaching from the direction of Badiceni) will not effectively serve its intended purpose. Vehicles waiting to turn right and those intending to go straight or turn left will obstruct each other due to the limited available space. This design may lead to operational conflicts and unnecessary delays at the intersection.

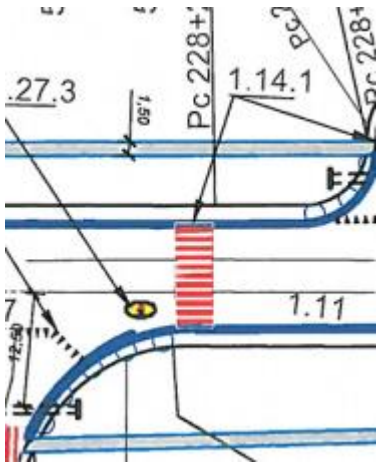
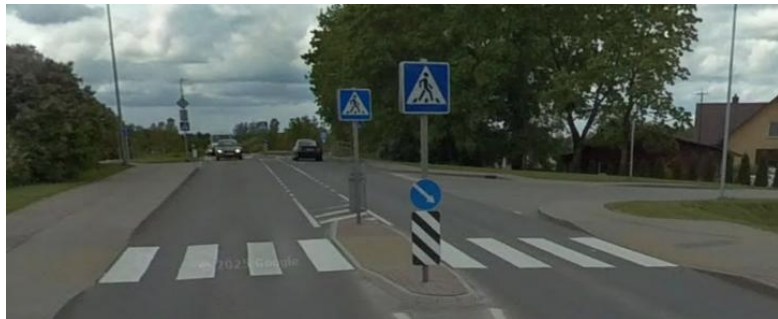
| 24. | PC 228+28<br>PC 230+59 | <p>At the reviewed location, an uncontrolled pedestrian crossing is proposed across three traffic lanes, with a total carriageway width of approximately 11.5 meters. For pedestrians—particularly elderly individuals—it may be difficult and unsafe to cross such a wide roadway in a single movement, increasing exposure time to vehicle traffic and overall risk.</p> | M | <p>To improve pedestrian safety, it is recommended to install a raised refuge island at the pedestrian crossing. This would provide pedestrians with a protected midpoint where they can cross one or two lanes first (depending on the direction of travel) and then assess traffic conditions before completing the crossing. The refuge island would not only enhance safety but also help visually narrow the roadway, encouraging drivers to reduce speed near the crossing.</p> <p><i>Example of traffic island for pedestrians</i></p> |

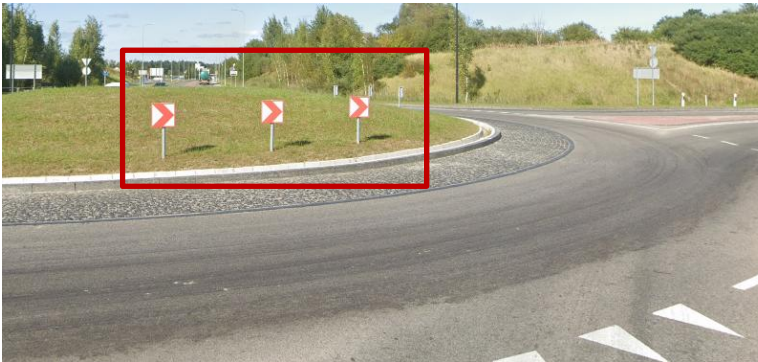
Example of directional segments (Lithuania)

4. Use appropriately sized and separated directional segments within the roundabout to ensure clarity and visibility.

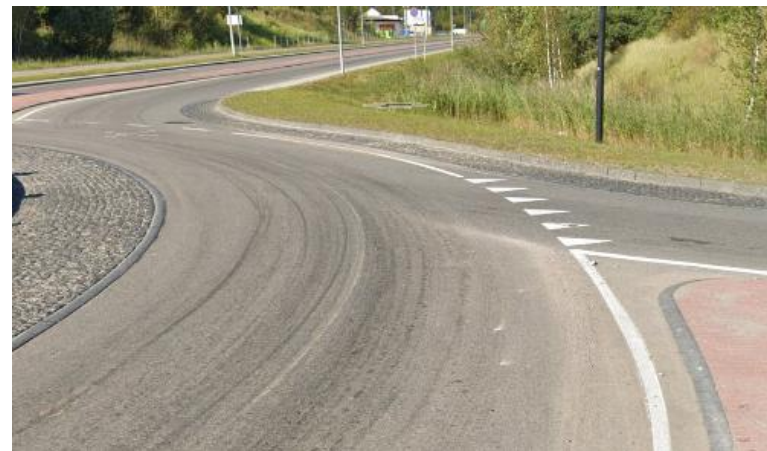
*Example of 1.13 marking in roundabouts (Lithuania)*

6. The 1.13 marking at the intersection is applied incorrectly.

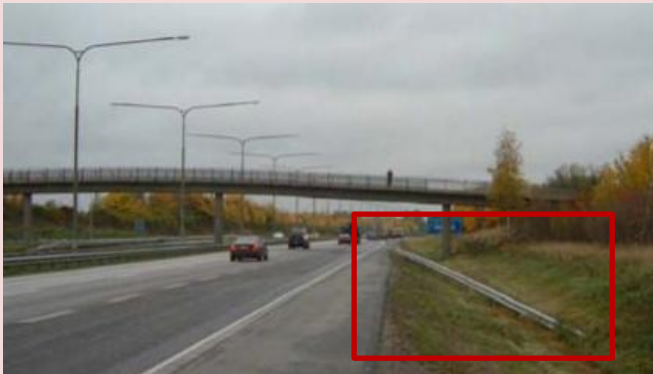
| 13. | PC 379+40 – 380+30<br>PC 384+53 – 389+70<br>PC 395+75 – 397+00<br>PC 406+84 – 407+24<br>PC 417+59 – 420+10<br>PC 478+70 – 480+70<br>PC 524+75 – 527+30<br>PC 530+80 – 535+50<br>PC 552+20 – 556+57<br>PC 560+20 – 563+20 | <p>Straight ends of safety barriers are unsafe because a head-on collision with them is likely to result in serious consequences for the road user's health. Such design solutions should be replaced with safer, impact-absorbing terminal ends or different layout of barriers.</p> | M | <p>Lower the ends of the barrier, rotate them away from driving direction and carriageway, dig them into the ground. The design of turned off the road, lowered to the ground level and dig into the ground barriers ensures less severe consequences in terms of accidents. Also, this design of barriers can help the vehicle get back on the road instead of overturns or crashes to surroundings.</p> |

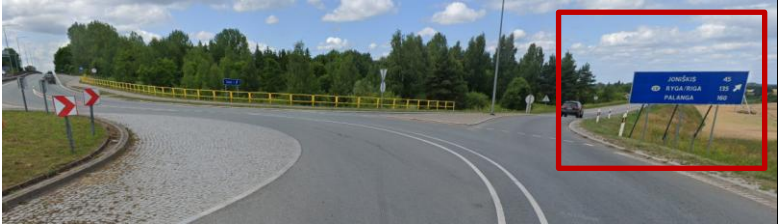
| 24. | PC 520+00 | <p>1. The proposed design includes a two-lane roundabout, which may be confusing and unsafe for drivers. Vehicles entering the second lane within the roundabout are required to perform a lane-change maneuver in order to exit, increasing the likelihood of conflict points and unsafe interactions.</p> | H | <p>1. The roundabout should be designed with clearly defined directional lanes that allow drivers to follow a single lane throughout the roundabout and exit without performing lane changes. Such a layout is known as a <i>turbo-roundabout</i>, which minimizes conflicts and improves safety.</p> |

| | | <div data-bbox="600 189 1126 735"></div> <div data-bbox="564 754 1126 1062"><p>2. There is insufficient advance information about the travel directions prior to the roundabout — drivers are not clearly informed about which exits lead to Drochia or other destinations.</p><p>3. The 1.13 marking at the intersection is applied incorrectly.</p></div> | <div data-bbox="1375 229 1901 596"></div> <div data-bbox="1458 617 1841 643"><p>Example of turbo-roundabout layout</p></div> <div data-bbox="1245 660 2056 871"><p>2. Install directional guidance signs clearly indicating which exits lead to Drochia and other key destinations. Additionally, provide advance lane selection signs before entry to the roundabout, showing which lane drivers must choose to reach their intended destination.</p></div> <div data-bbox="1281 890 2056 1114"></div> <div data-bbox="1386 1131 1910 1157"><p>Example of directional guidance signs (Lithuania)</p></div> <div data-bbox="1245 1216 2056 1337"><p>3. Correct the alignment and placement of marking 1.13 so that it follows the geometry of the inner carriageway, ensuring consistent and clear stop-line visibility.</p></div> |

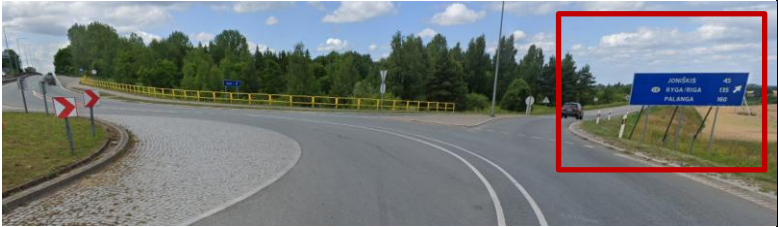
| 28. | PC 593+50 | <p>1. The proposed design includes a two-lane roundabout, which may be confusing and unsafe for drivers. Vehicles entering the second lane within the roundabout are required to perform a lane-change maneuver</p> | H | <p>1. The roundabout should be designed with clearly defined directional lanes that allow drivers to follow a single lane throughout the roundabout and exit without performing lane changes. Such a layout is known as a <i>turbo-roundabout</i>, which minimizes conflicts and improves safety.</p> |

| | <p>in order to exit, increasing the likelihood of conflict points and unsafe interactions.</p> <p>2. There is insufficient advance information about the travel directions prior to the roundabout — drivers are not clearly informed about which exits lead to Drochia or other destinations.</p> <p>3. The 1.13 marking at the intersection is applied incorrectly.</p> | <p><i>Example of turbo-roundabout layout</i></p> <p>2. Install directional guidance signs clearly indicating which exits lead to Riscani and other key destinations. Additionally, provide advance lane selection signs before entry to the roundabout, showing which lane drivers must choose to reach their intended destination.</p> <p><i>Example of directional guidance signs (Lithuania)</i></p> <p>3. Correct the alignment and placement of marking 1.13 so that it follows the geometry of the inner carriageway, ensuring consistent and clear stop-line visibility.</p> |

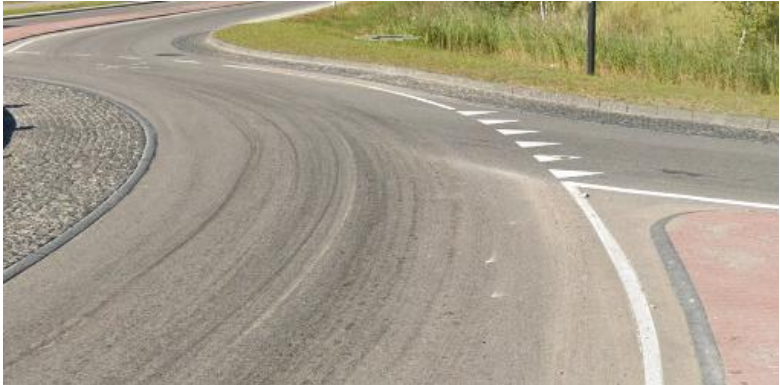
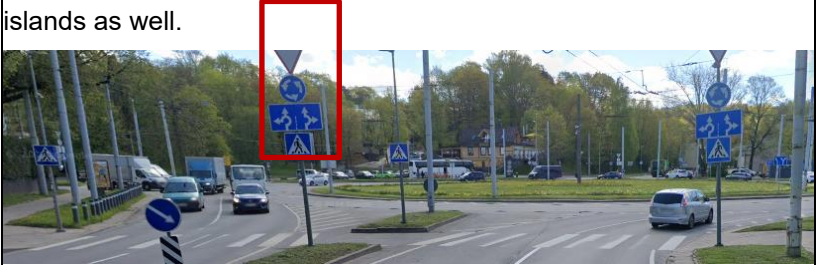
| | | <p>4. Pedestrian crossings with safety islands are planned before the roundabout; however, pedestrian crossing signs are not provided on the safety islands.</p> | <p><i>Example of 1.13 marking in roundabouts (Lithuania)</i></p> <p>4. It is recommended to install pedestrian crossing signs on the safety islands as well.</p> <p><i>Example of pedestrian crossing road signs in roundabouts (Lithuania)</i></p> <p>5. Design appropriate pedestrian infrastructure that connects</p> |

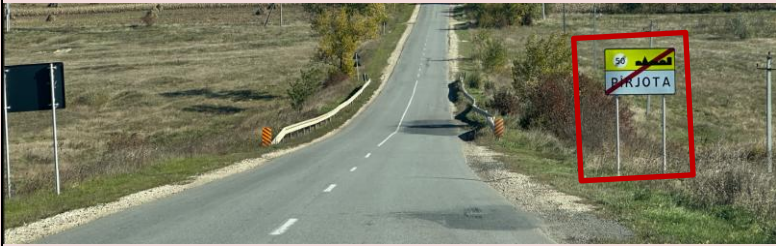
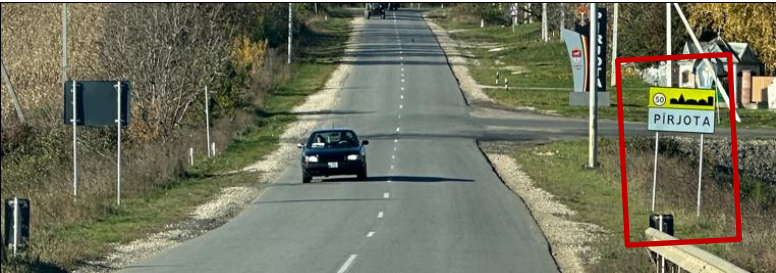
| 29. | PC 327+50<br>PC 412+63<br>PC 437+50 | <p>The signs indicating the start and end of the settlement are planned only on one side of the road. As a result, road users—especially when exiting the settlement—may not notice the signs, since they are located on the opposite side.</p> | <p>L</p> <p>Install settlement start and end signs on both sides of the road. One side should indicate the end of the settlement, and the other side should indicate the start, consistent with the current practice on the R7 road.</p> |

| | | | <p>Example of road signs to inform about start/end of settlement currently on R7 road</p> |

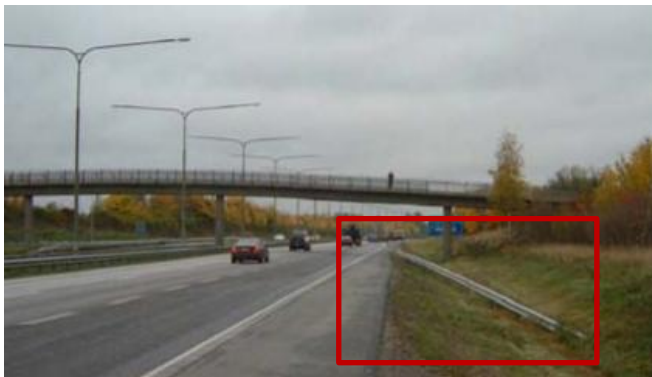
| 4. | <p>PC 615+20 – 619+50<br/>PC 632+30 – 639+00<br/>PC 647+00 – 647+67<br/>PC 647+00 – 652+20<br/>PC 654+29 – 655+02<br/>PC 655+47 – 657+50<br/>PC 655+58 – 657+30<br/>PC 669+02 – 669+50<br/>PC 696+25 – 699+95<br/>PC 699+85 – 702+46<br/>PC 724+20 – 725+48</p> | <p>Straight ends of safety barriers are unsafe because a head-on collision with them is likely to result in serious consequences for the road user's health. Such design solutions should be replaced with safer, impact-absorbing terminal ends or different layout of barriers.</p> | M | <p>Lower the ends of the barrier, rotate them away from driving direction and carriageway, dig them into the ground. The design of turned off the road, lowered to the ground level and dig into the ground barriers ensures less severe consequences in terms of accidents. Also, this design of barriers can help the vehicle get back on the road instead of overturns or crashes to surroundings.</p> |

| | PC 754+10 – 755+01<br>PC 764+64 – 766+38<br>PC 773+20 – 775+10<br>PC 776+18 – 778+40<br>PC 780+40 – 782+92<br>PC 785+50 – 786+50<br>PC 875+68 – 875+92<br>PC 880+53 – 880+77<br>PC 886+01 – 886+25 | | | |

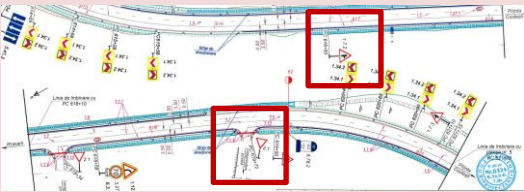
| 5. | PC 616+83 | <p>Road sign 1.7.2 informs drivers about an upcoming junction on the right side, but it only indicates the nearest intersection. There is no repeated sign for the junction at PC 619+72.</p> | L | <p>It is recommended to install road signs 1.7.2 before each junction to properly inform drivers—specifically, add the corresponding sign when approaching the junction at PC 619+72 so drivers are aware of the side road on the right.</p> <p>Additionally, road signs 1.7.3 should be installed in the opposite driving direction so that drivers are informed about side-road intersections regardless of the direction they are traveling.</p> |

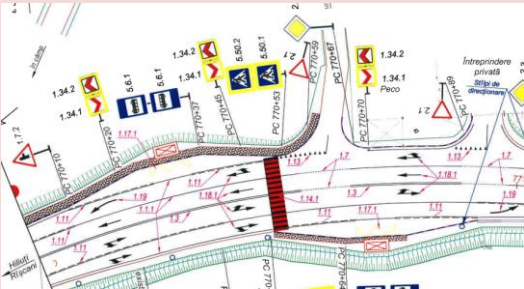
PC 834+50  
PC 837+46  
PC 841+00

Additionally, the current layout creates unnecessary conflict points between vehicles and pedestrians, and the lack of clear lane guidance increases the risk of side collisions and chaotic driver behavior.

| | | <p>PC 834+50</p> <p>PC 837+46</p> <p>PC 841+00</p> | | <p>PC 834+50 (please see enlarged in Annex C)</p> <p>PC 837+46 (please see enlarged in Annex C)</p> <p>PC 841+00 (please see enlarged in Annex C)</p> |
